SUMMARY OF TESTING RESULTS FOR:

Leafygreen.info

PRO ENERGY CONSULTANTS

Summary of Testing Results

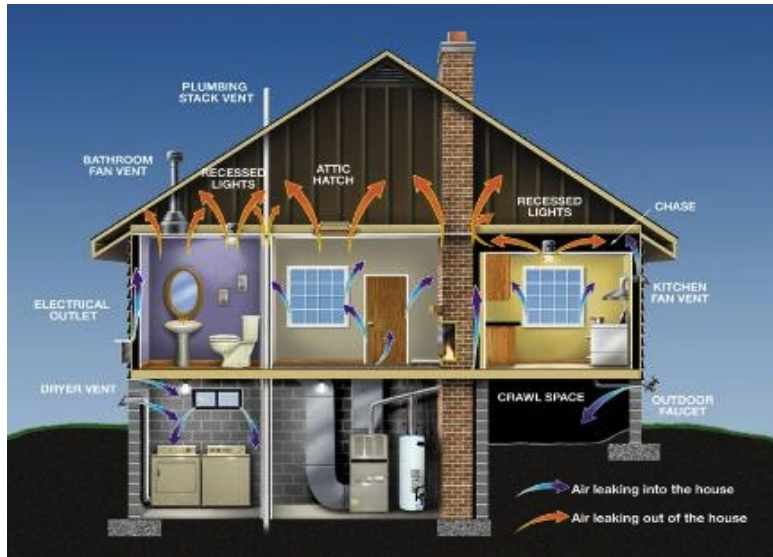
Stack Effect Illustration

This illustration shows how conditioned air is lost and unconditioned air enters the building.

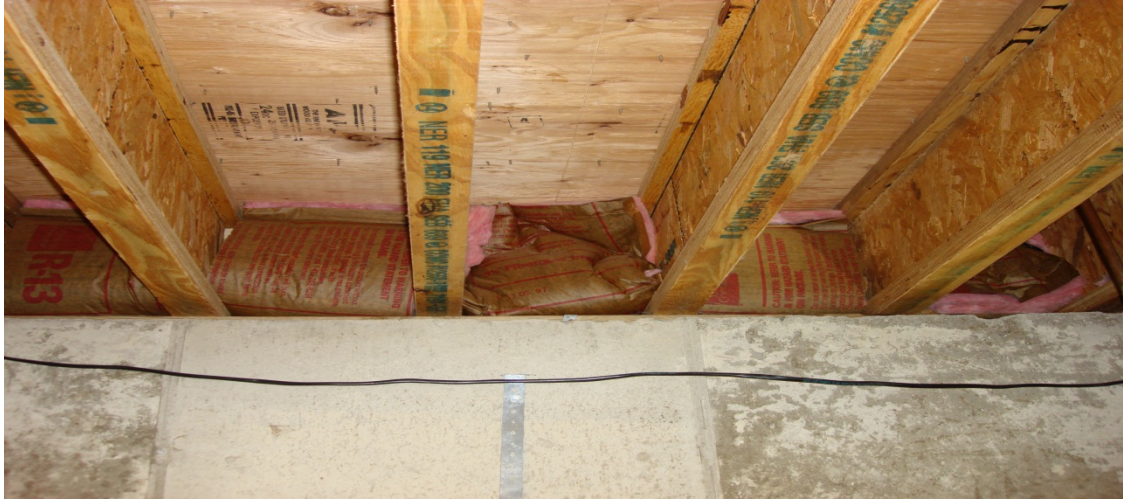
Basement rim Joist insulation

- Air seal and insulate the rim joist. The rim joist is located at the top of the concrete basement walls and when not air sealed and insulated causes air to move within your walls. This can be accomplished by cutting foam core board to fit in the pocket formed by the rafters, rim joist and top of the foundation wall. Use nonexpanding foam to glue these pieces in place and fill any gaps.

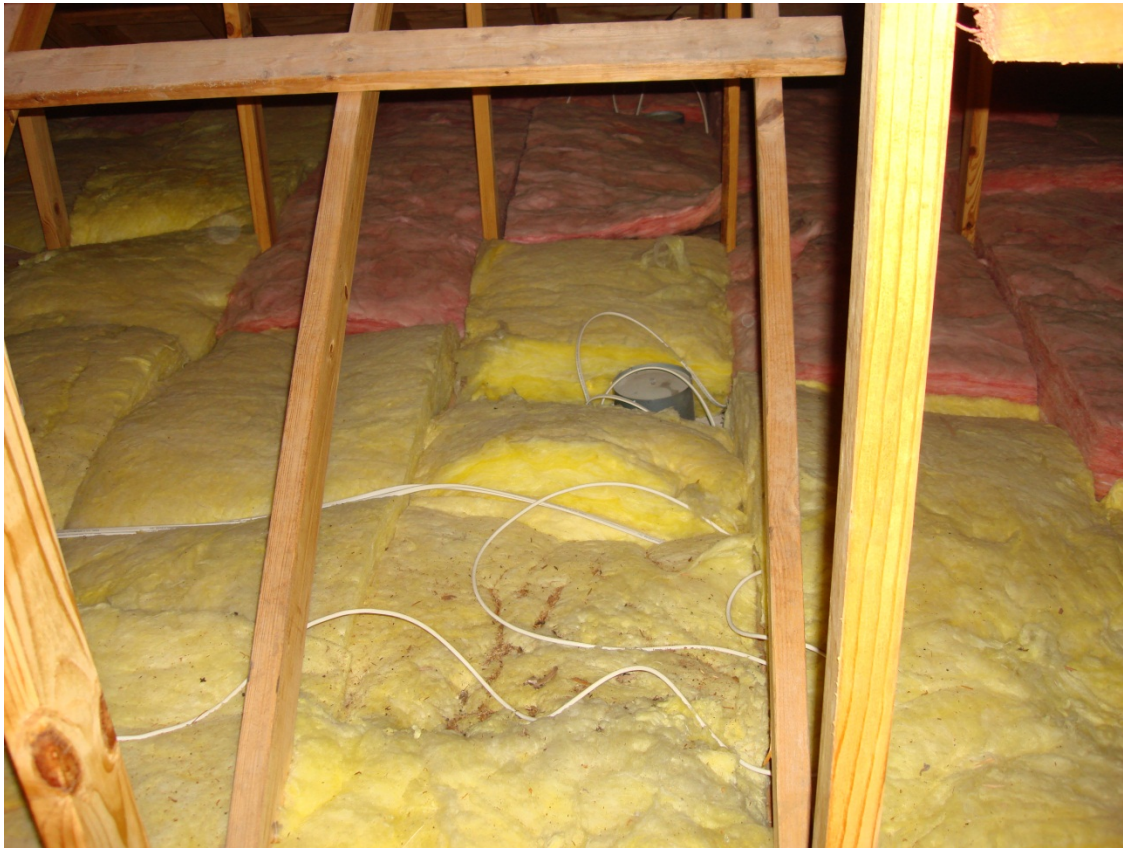
Hole in attic insulation for recessed light

- Seal the gap between the recessed light and the ceiling.
- Place foam sealing pads behind electrical outlets.
- Apply mastic to all accessible HVAC duct joints.

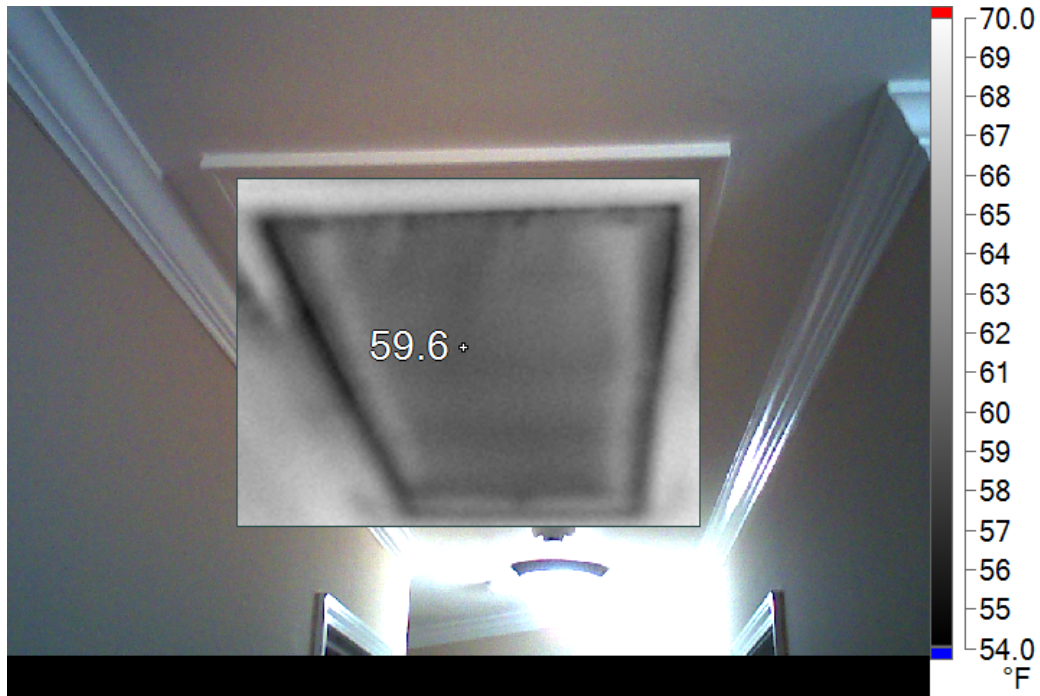
- The attic hatch is allowing hot attic air into the second floor of your home during hot weather and cold air infiltration during the winter. The cold air causes condensation to form when the hot and cold air meet and has the effect of lowering humidity. Both of these situations carry health and comfort concerns.
- Plumbing and electrical openings were showing large amounts of air flow. This air is coming from your attic and or basement and has the effect of bringing dust and non-conditioned air into your home.
- The rim joist, while insulated with fiberglass batts, does not have an air barrier. This constitutes a hole in the thermal barrier of your home.

Thermal and air leak at attic hatch

- Repair (using nonexpanding foam) all damaged, gapped or missing fiberglass batt insulation.
- Install an Attic Tent above the pull down attic stairs to provide a thermal and air seal between the attic and second floor.

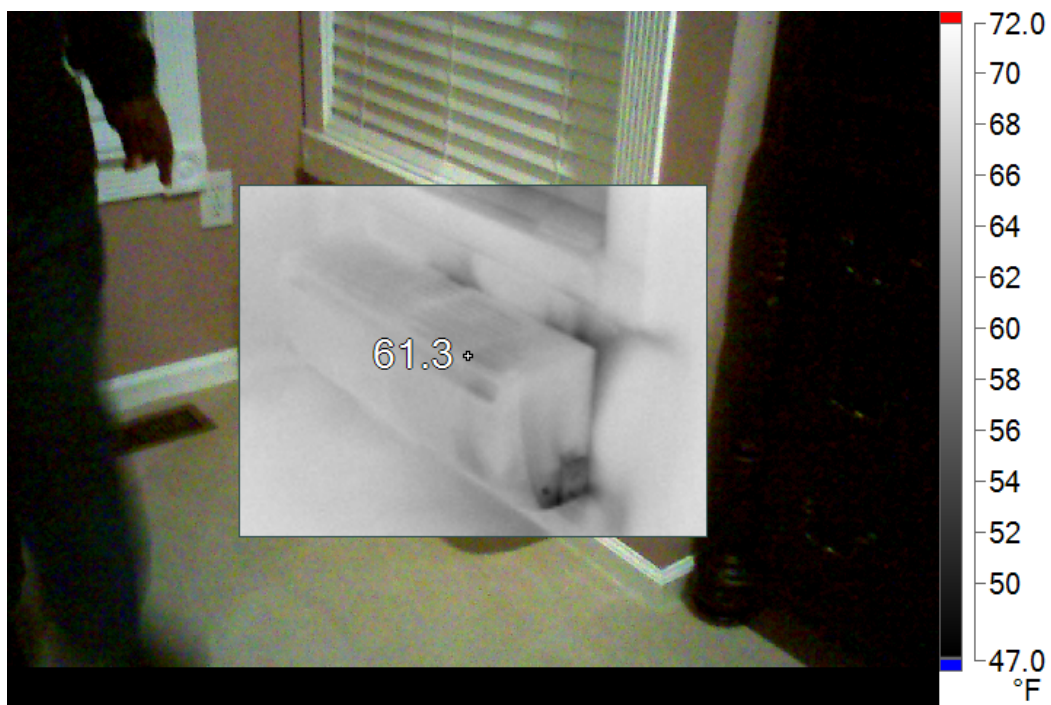
Thermal and air leak around room AC unit

- Using a non-expanding foam product or silicone caulking to seal between AC delivery and return vents and the surrounding sheet rock or floor.
- Use a nonexpanding foam product to seal around the room air conditioner

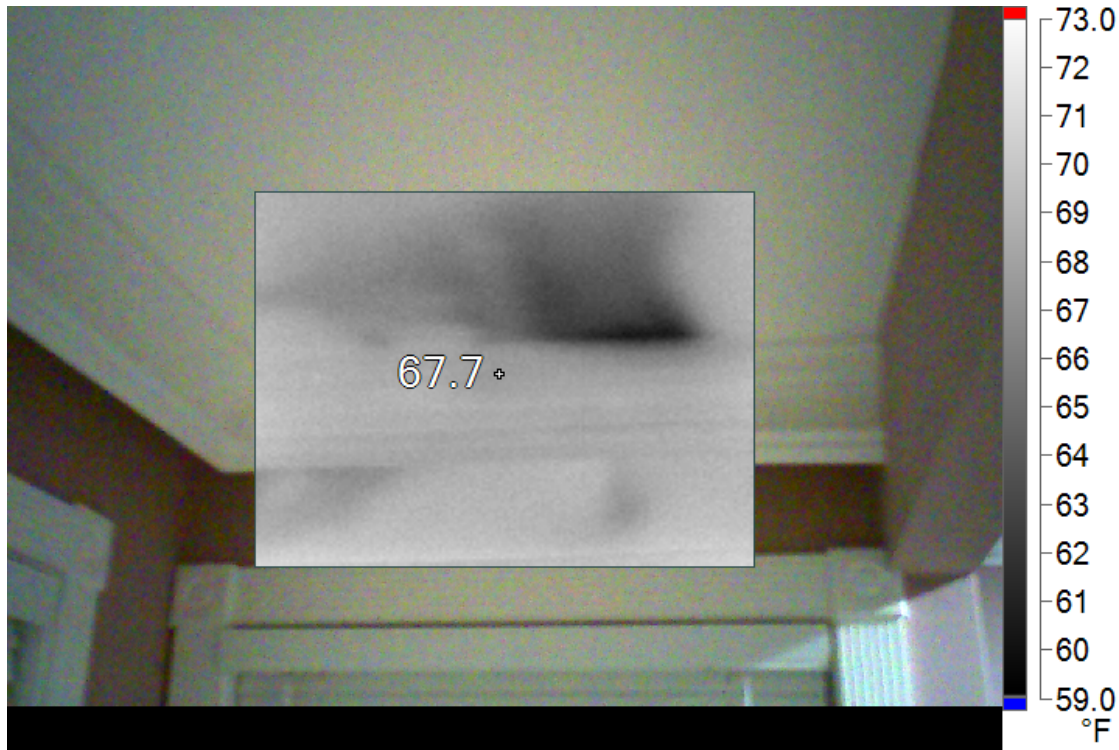
Missing insulation
